Analysis of the UIW Riparian Environment

Edward Palomo¹, Hoang Tran², Juan Martinez² and Dr. Karen Engates³

¹Highlands High School, ²Edison High School, ³University of the Incarnate Word MSE

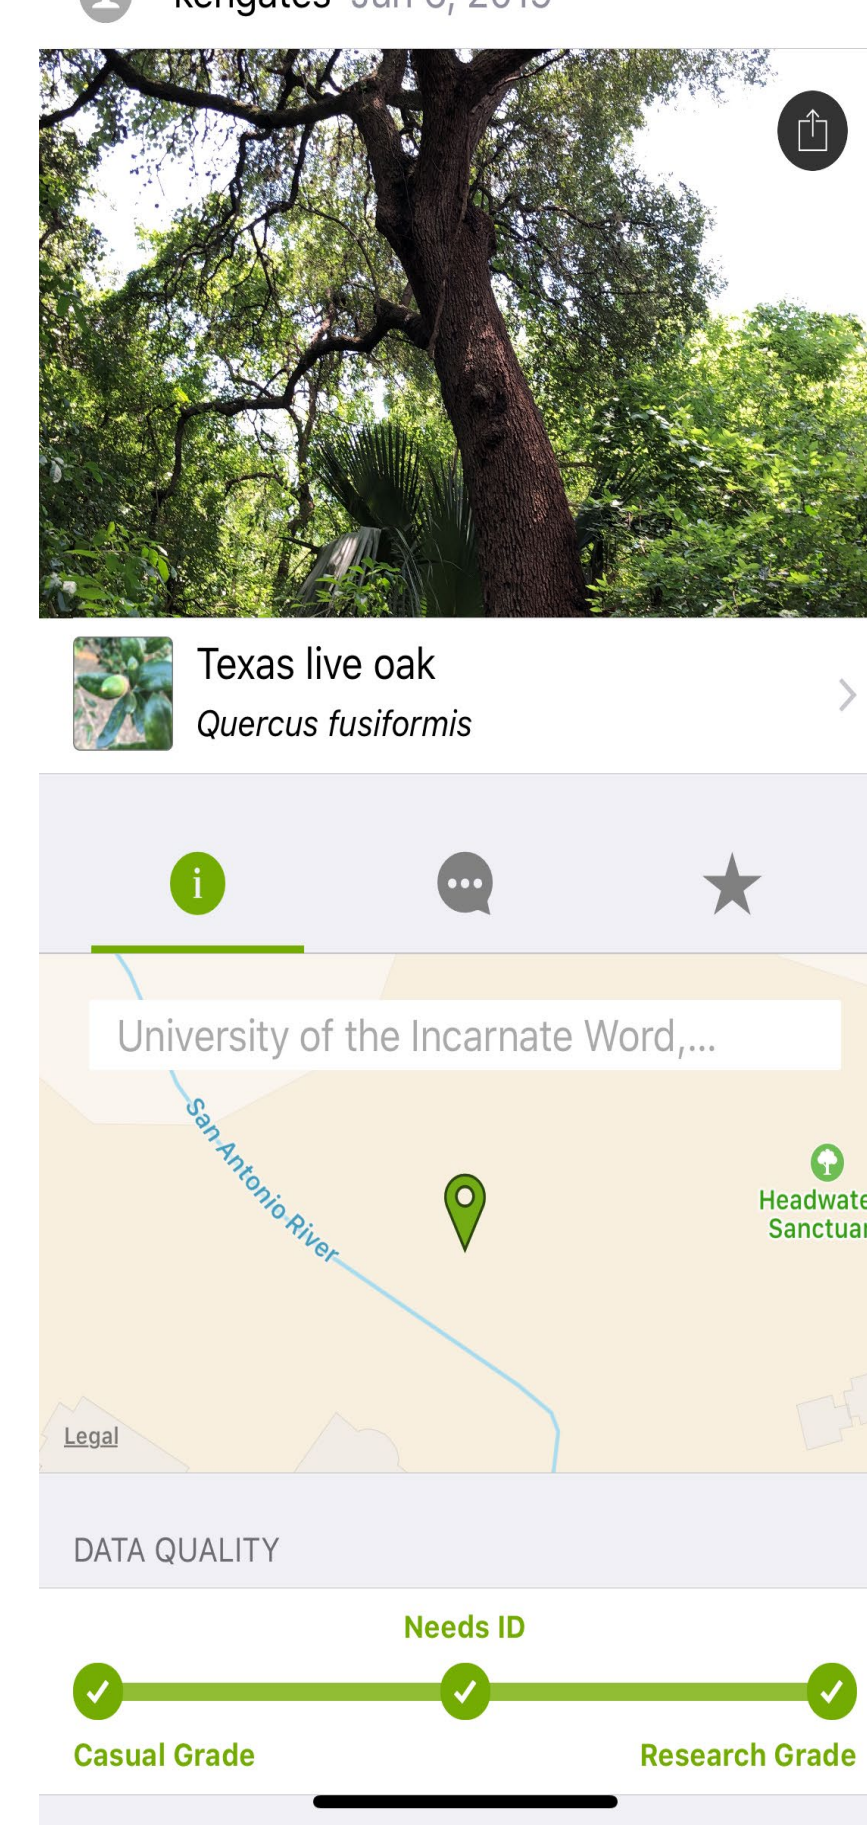
Figure 3 (left): Example of iNaturalist observation.

iNaturalist Identified Species:
Quercus fusiformis (Texas live oak)
 Class Diplopoda (millipedes)
Malvaviscus arboreus (Turk's cap)
Dolichandra unguis-cati (catclaw vine)
Argia sp. (Dancers dragonfly)
 Multiple unknown identifications

- Dissolved oxygen values indicated a healthy water source for living organisms with the minimum being 5 mg/L.
- iNaturalist app was easy to use to attempt to identify organisms, but not all images were able to be identified.

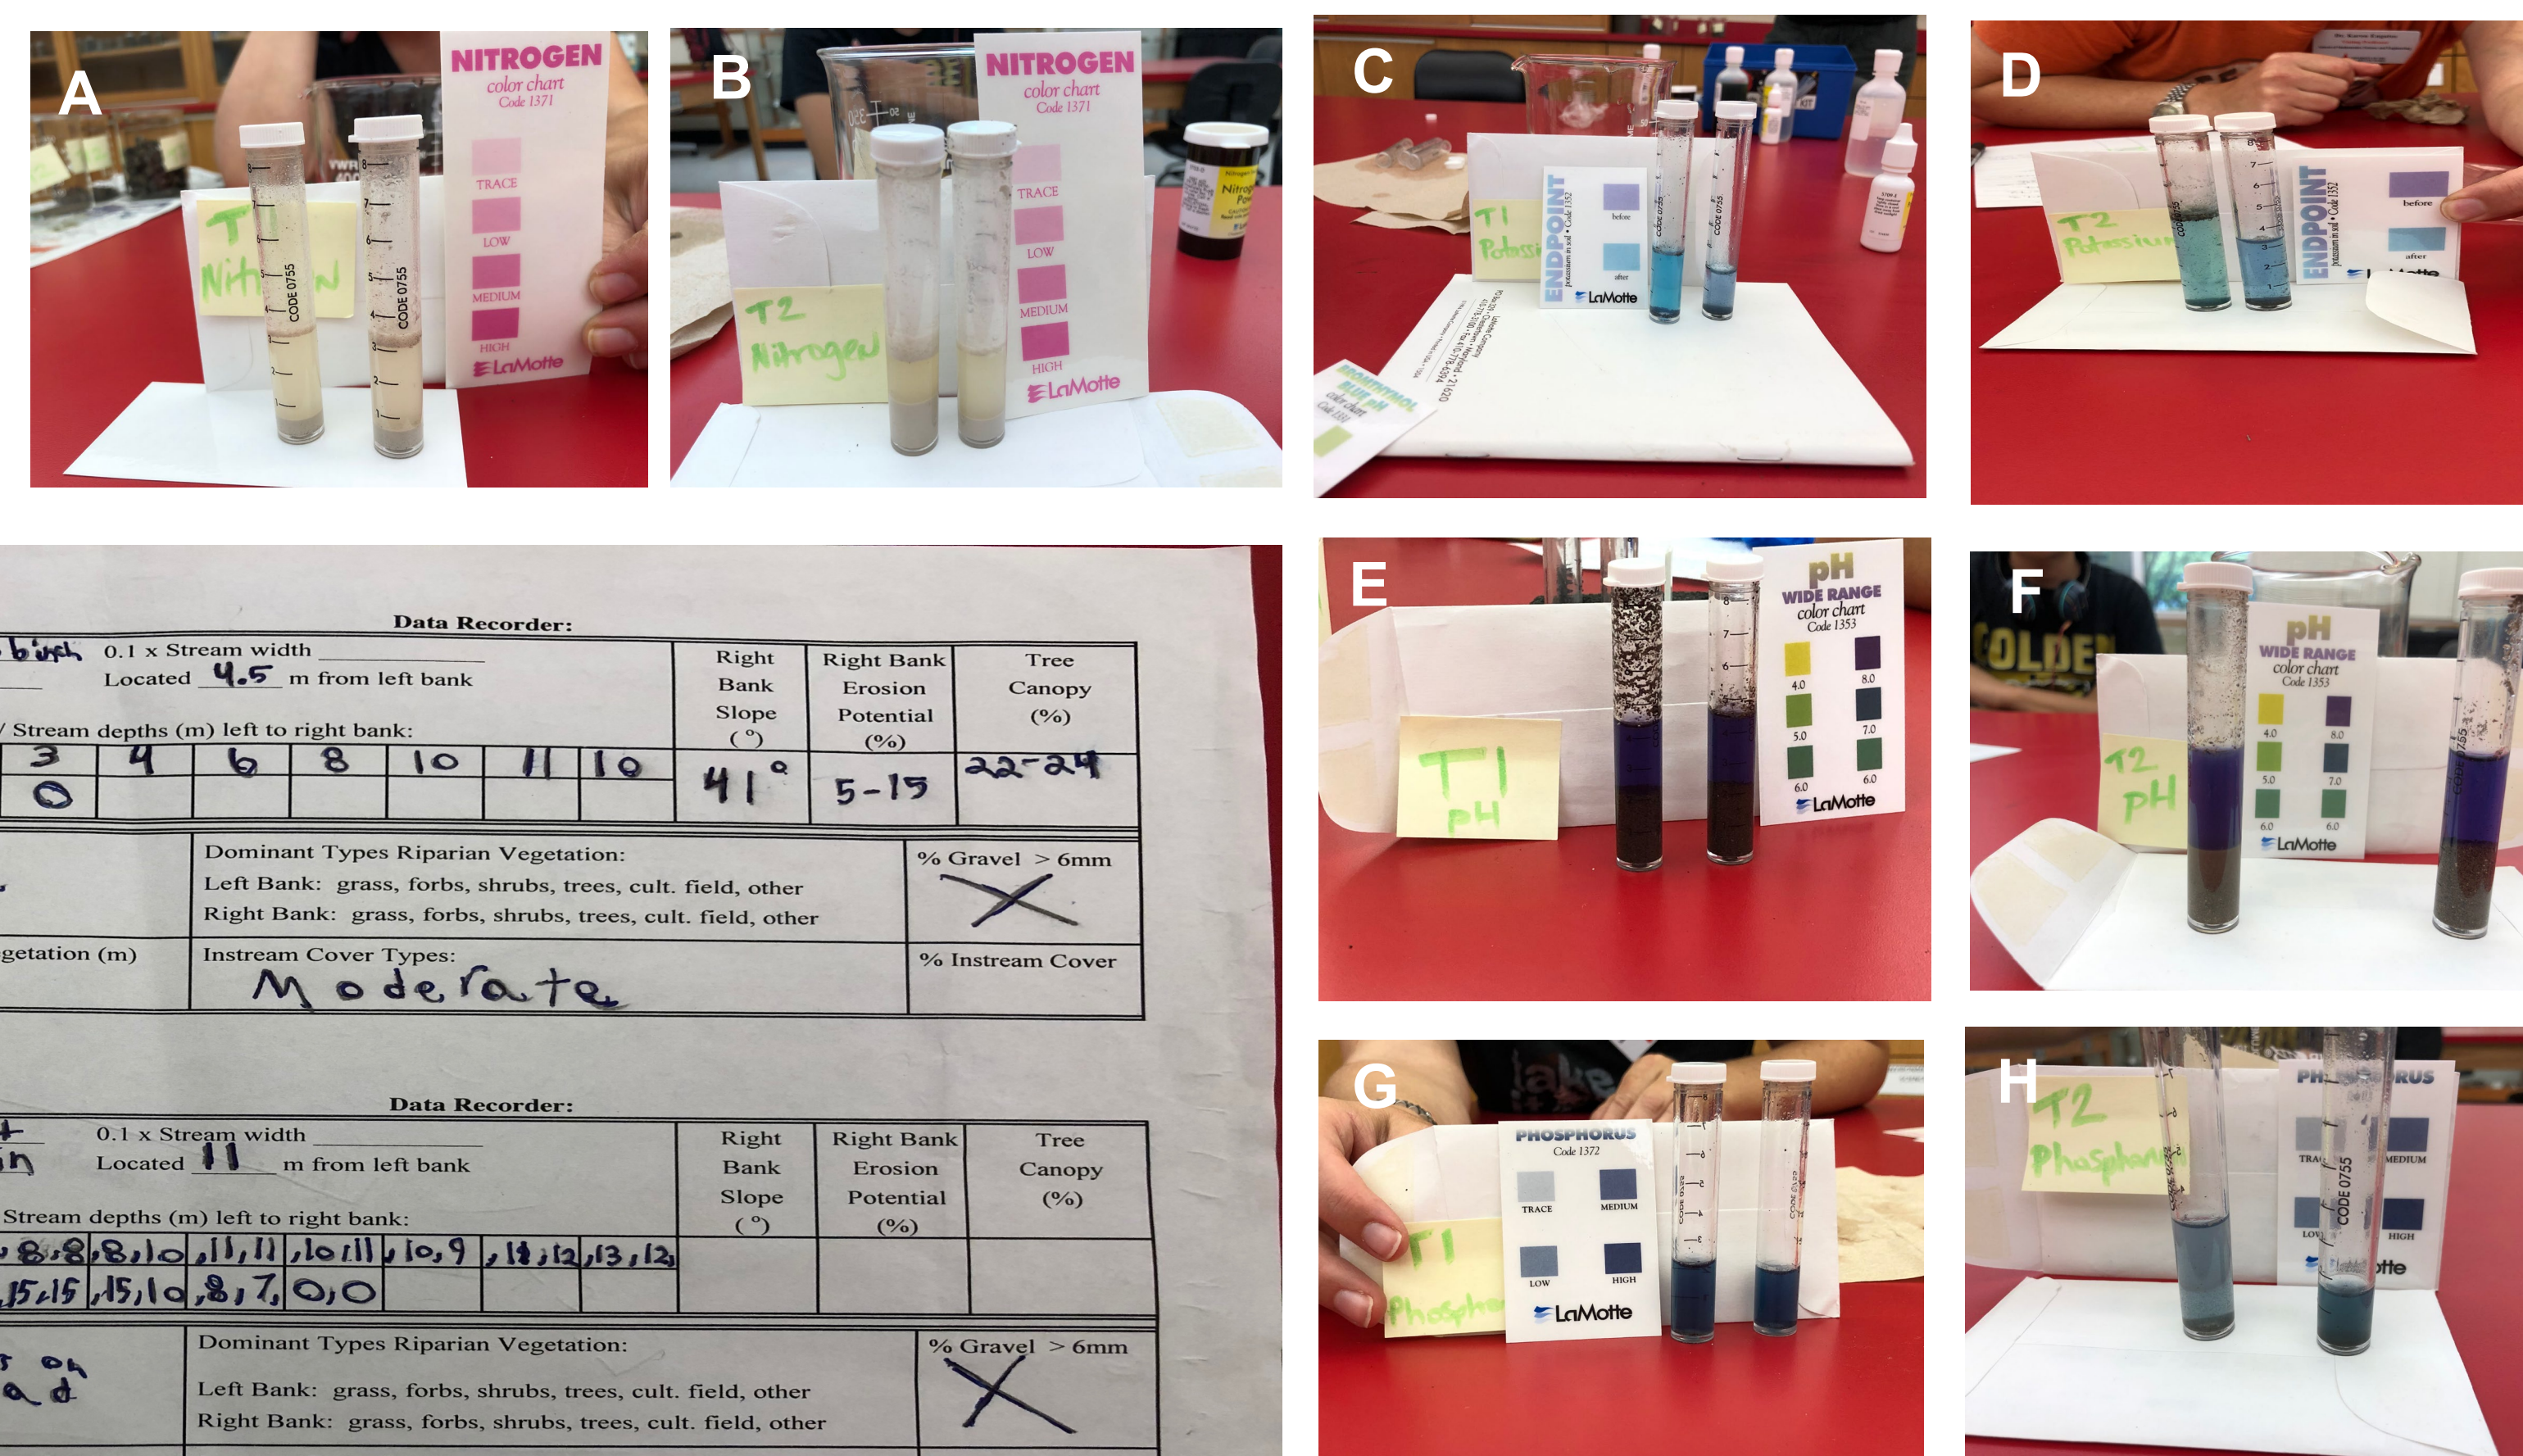
Figures 5A-H show soil testing results. A-B) nitrogen; C-D) potassium; E-F) pH; G-H) phosphorus.

- Conductivity values fell within natural water range (100-1000 uS/cm) and therefore did not indicate industrial waste present (10,000+ uS/cm).
- No confidence was given to soil nitrogen results indicating lack of nitrogen because the area is heavily vegetated and therefore much nitrogen exists. Soil phosphorus was indicative of this type of area.

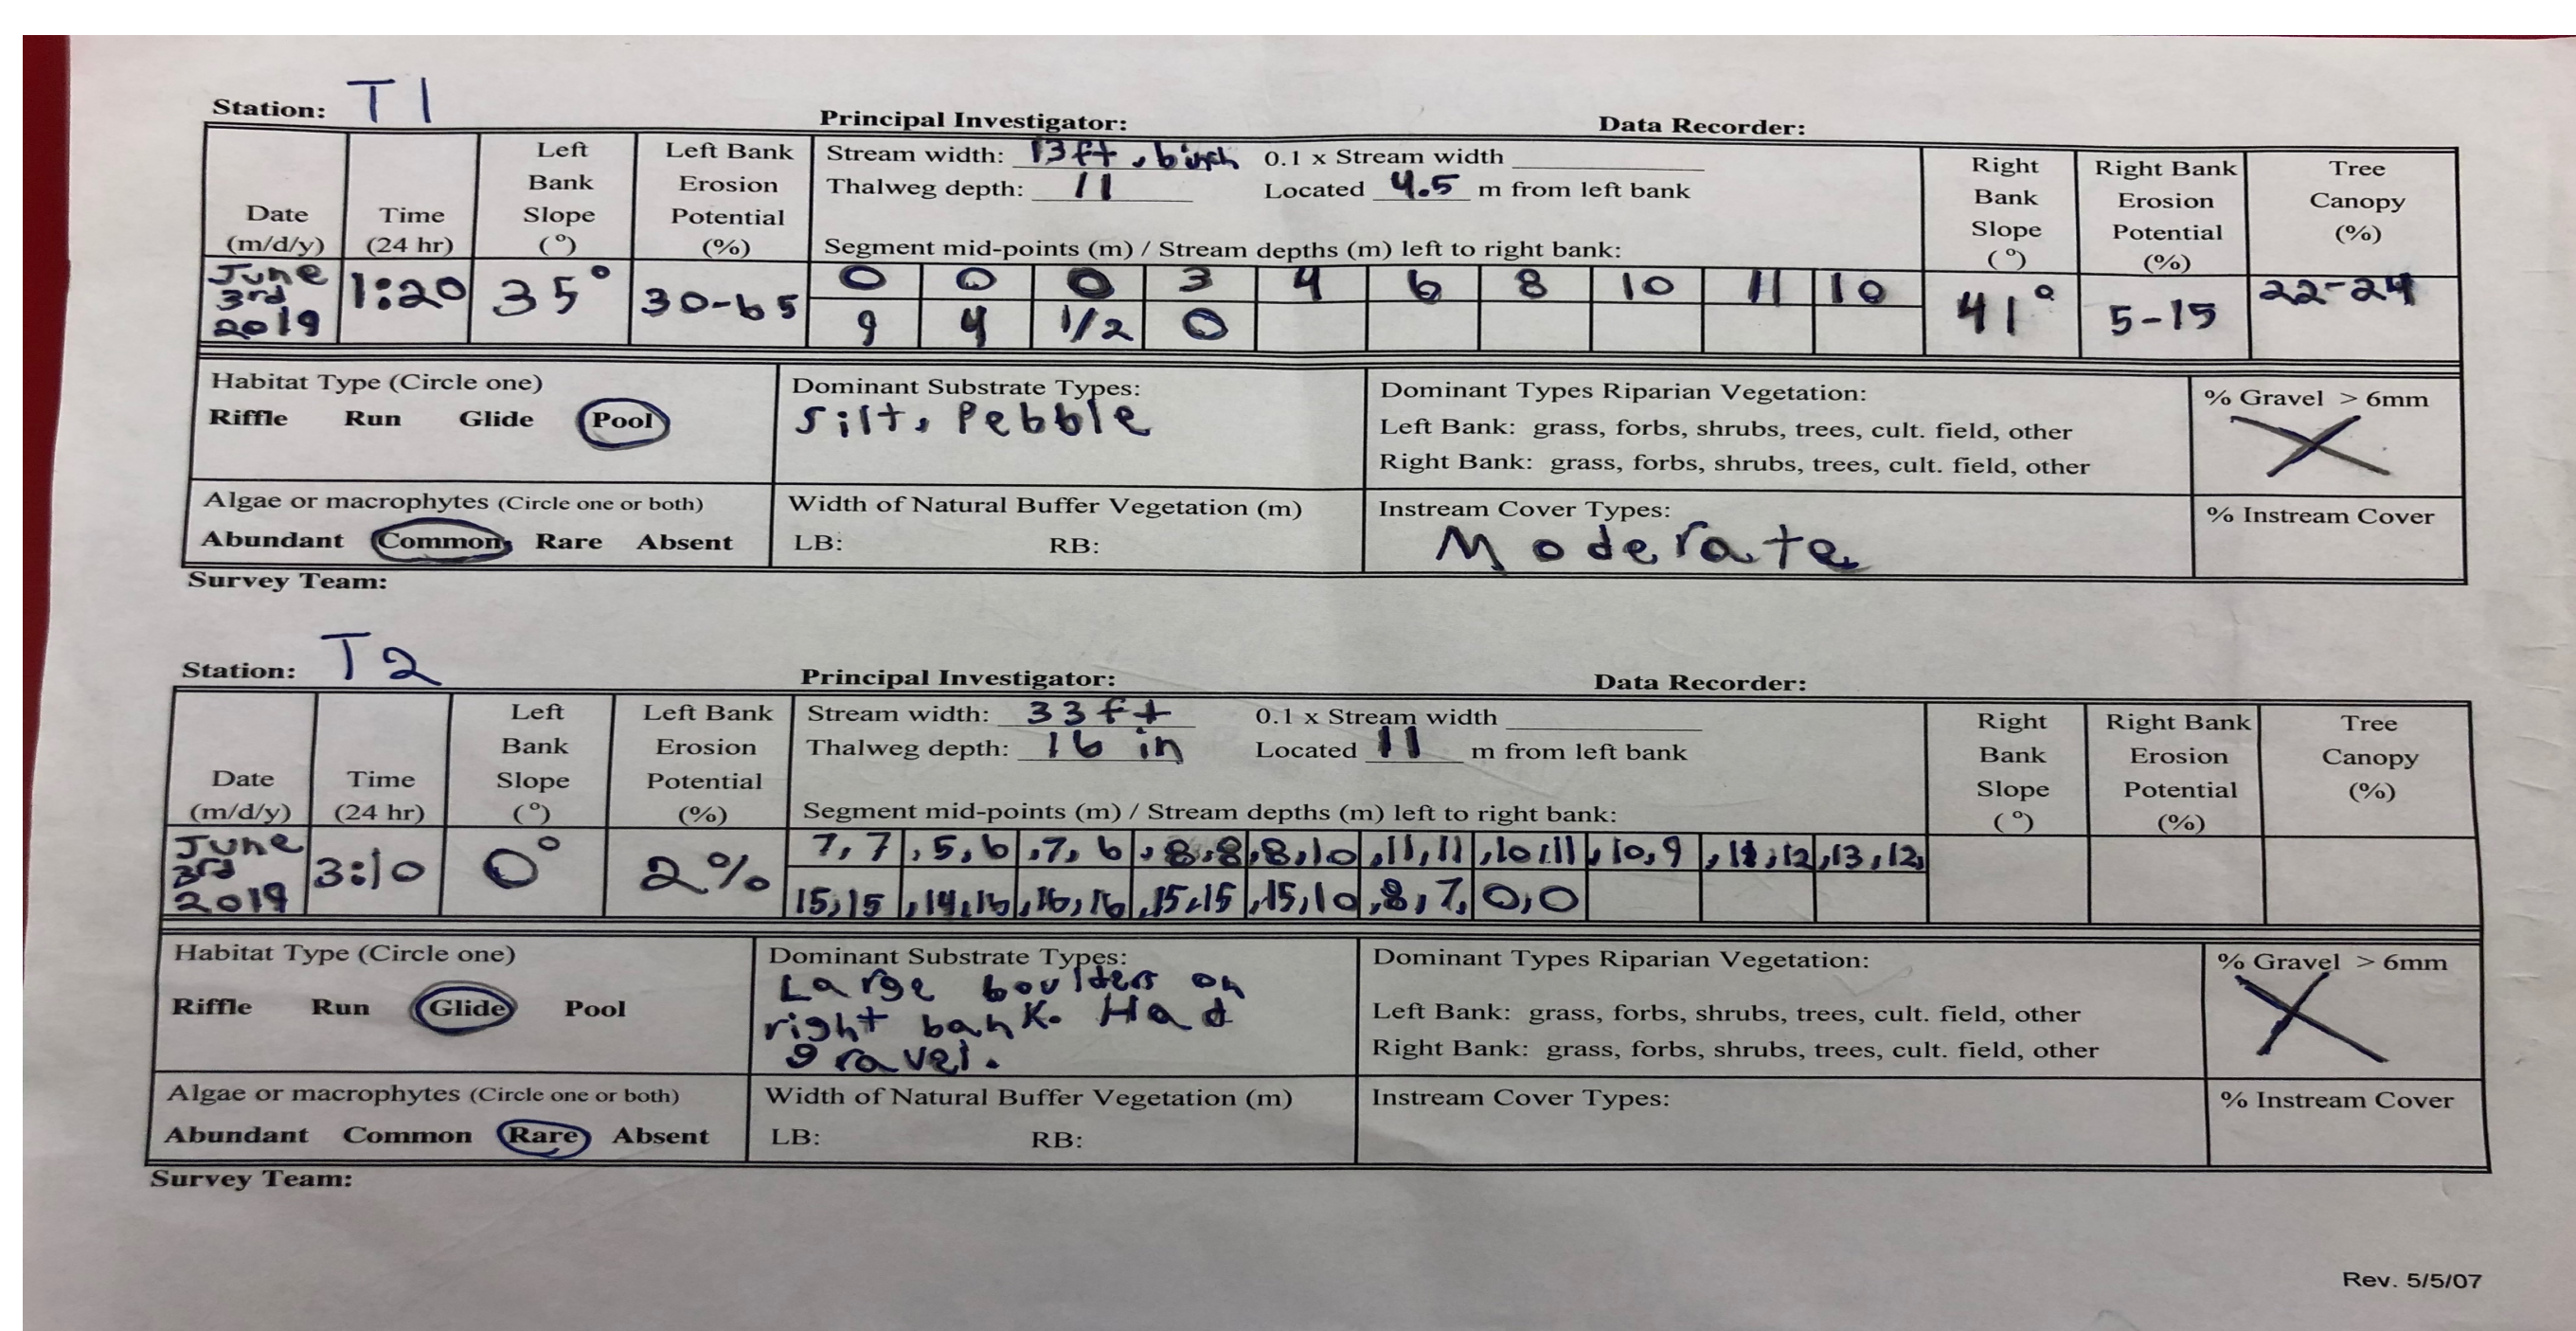
Figure 4 shows riparian habitat protocol data observations.
